# Update

September 2017

on the Comox Valley Waste Management Centre Engineered Landfill Cell 1 Construction

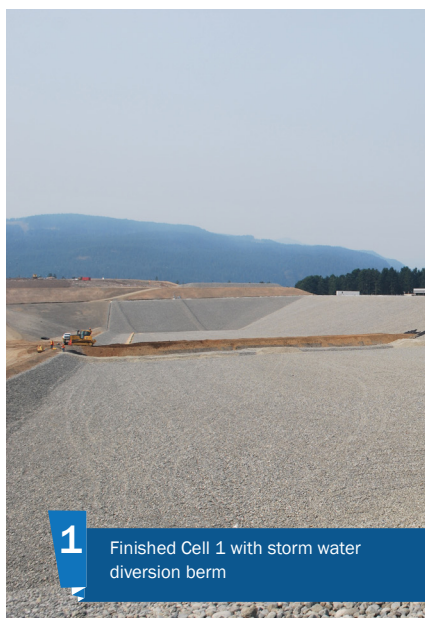
Finished Cell 1 with storm water diversion berm

The finalized Cell 1 can be seen in [Photo 1](#). A temporary berm has been constructed to divert clean storm water away before it contacts any waste. The diversion of clean storm water will reduce the total volume of leachate generated in Cell 1. This helps to ensure sufficient storage capacity in the equalization pond and potentially reduces operating costs at the leachate treatment facility.

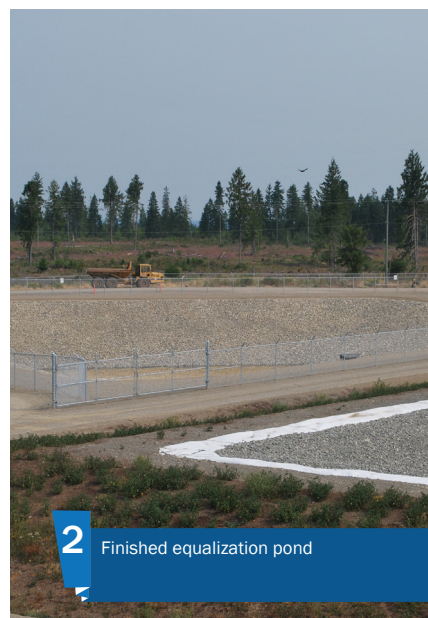
2

Finished equalization pond

The finished equalization pond can be seen in [Photo 2](#). Leachate will be stored in this pond before being treated in the future onsite leachate treatment plant. A leak detection layer has been installed between the two lining systems in the equalization pond to continually monitor the performance of the liner and ensure environmental protection.

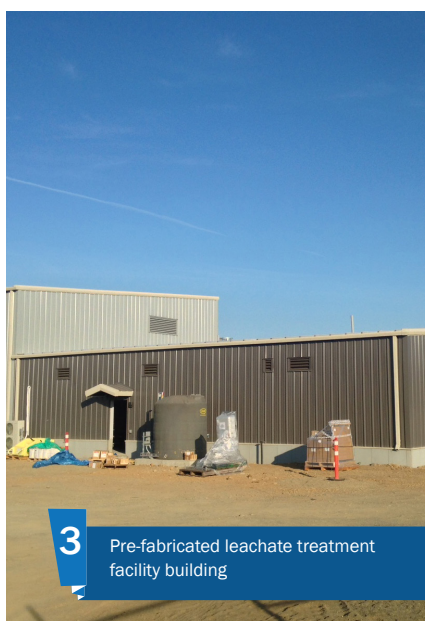
3

Pre-fabricated leachate treatment facility building

The pre-fabricated leachate treatment facility building is now assembled on site ([see Photo 3](#)). All of the treatment process equipment and machinery has been delivered and installation of the equipment, machinery, and piping is currently underway ([see Photo 4](#)).

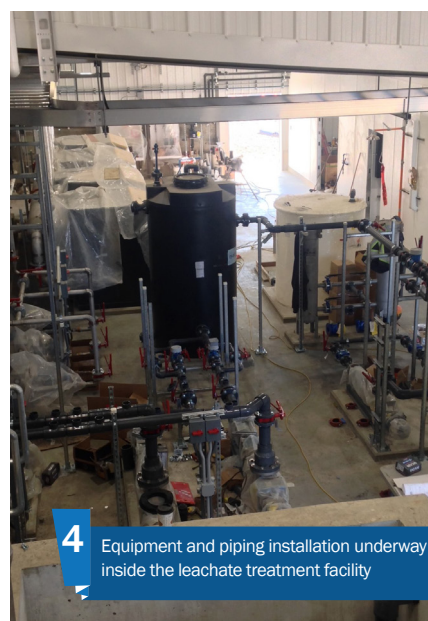
4

Equipment and piping installation underway inside the leachate treatment facility

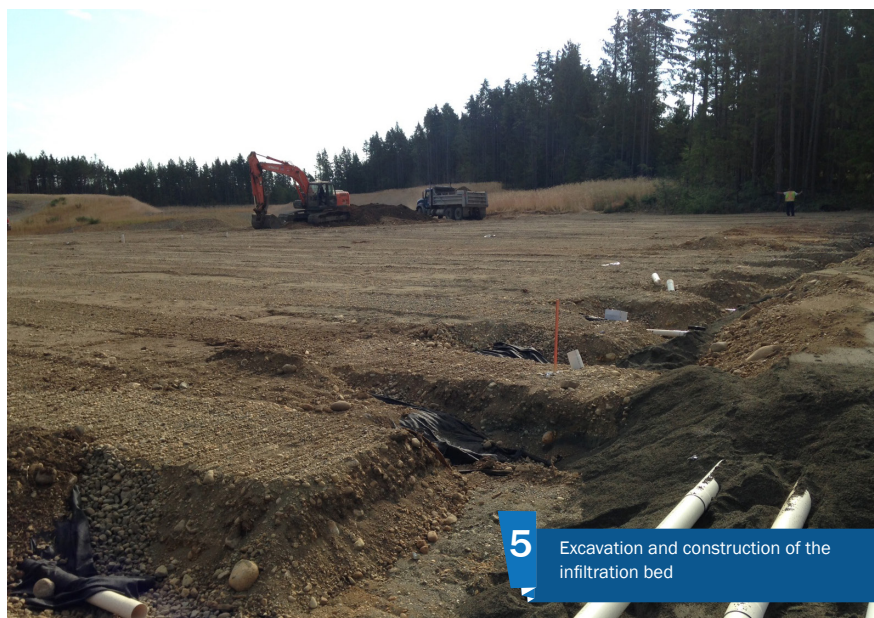
5

Excavation and construction of the infiltration bed

The construction of the infiltration bed – where treated leachate will be returned as clean water to the environment – has been completed including excavation, piping installation and drain rock placement ([see Photo 5](#)). Testing and commissioning of the leachate treatment facility, including the infiltration bed, is expected to begin in October 2017.
